SBCA TREE CONSULTING

Date: January 20, 2015

Location: 915 Broadway

Subject: Tree Safety Inspection

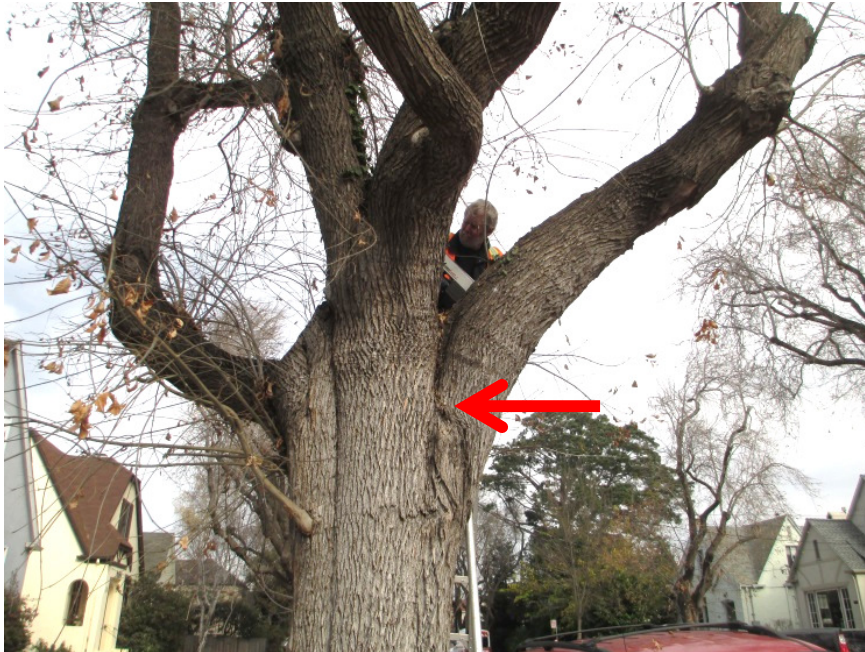
The 18 ½ inch diameter stem selected for investigation with the Resistograph has a high “target” rating because it has developed over a relatively busy street. The large stem is also weakly attached due to what is commonly referred to as “included or embedded bark”. Results of the Resistograph investigation indicated significant decay throughout the 18 ½ inch stem.

Photo 1. Photo to left shows arborist using the Resistograph to determine the level of decay. The area of Resistograph investigation was determined by sounding the trunk and scaffold using a mallet. Two borings were administered; the boring shown in the photo above is from the upper north side. A second boring was taken on the lower south side of the stem on the same cross sectional area. The stem being investigated has grown toward the street.

Compounding the decay level is the included bark attachment identified by the red arrow.

Remove tree as soon as it can be undertaken efficiently. Tree removal should occur prior to the spring when leaves develop, resulting in additional weight and wind sail.

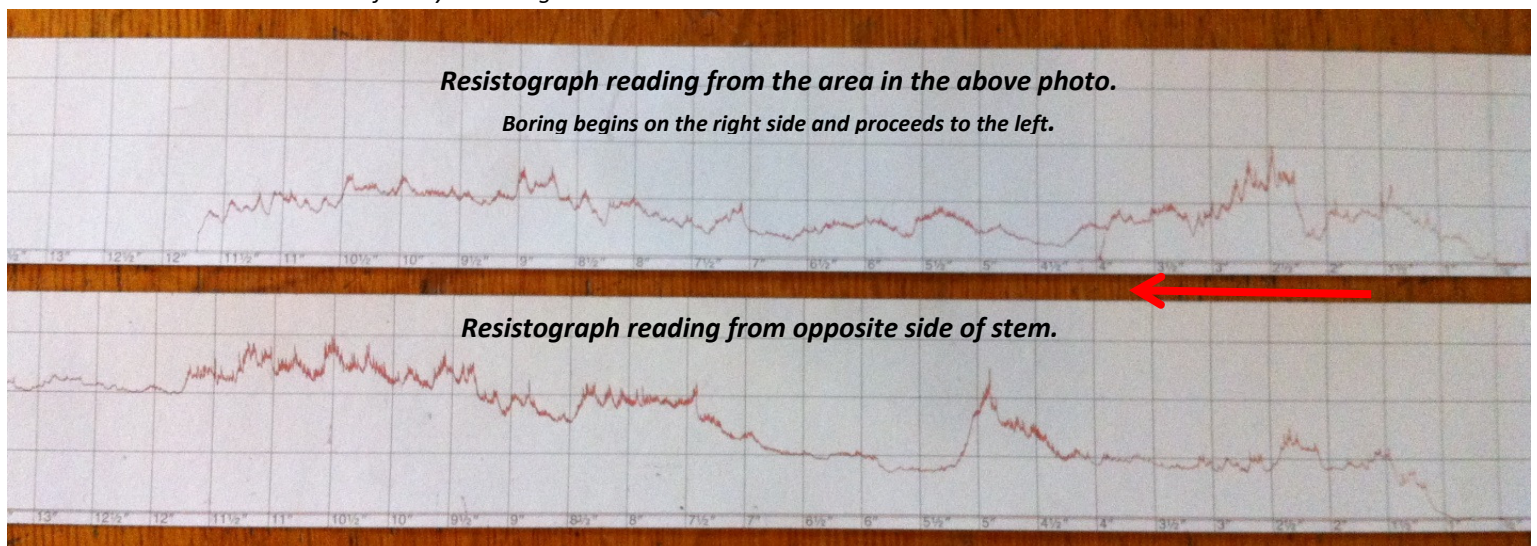
Photo 2. Photo below shows Resistograph boring recordings. The lines created by the Resistograph show many dips and a failure to increase in resistance. This indicates the area of the boring holes contain significant decay, which was also identified by sounding with a mallet.
